The Beach Review & Assessment Committee

Interim Report
May 2003

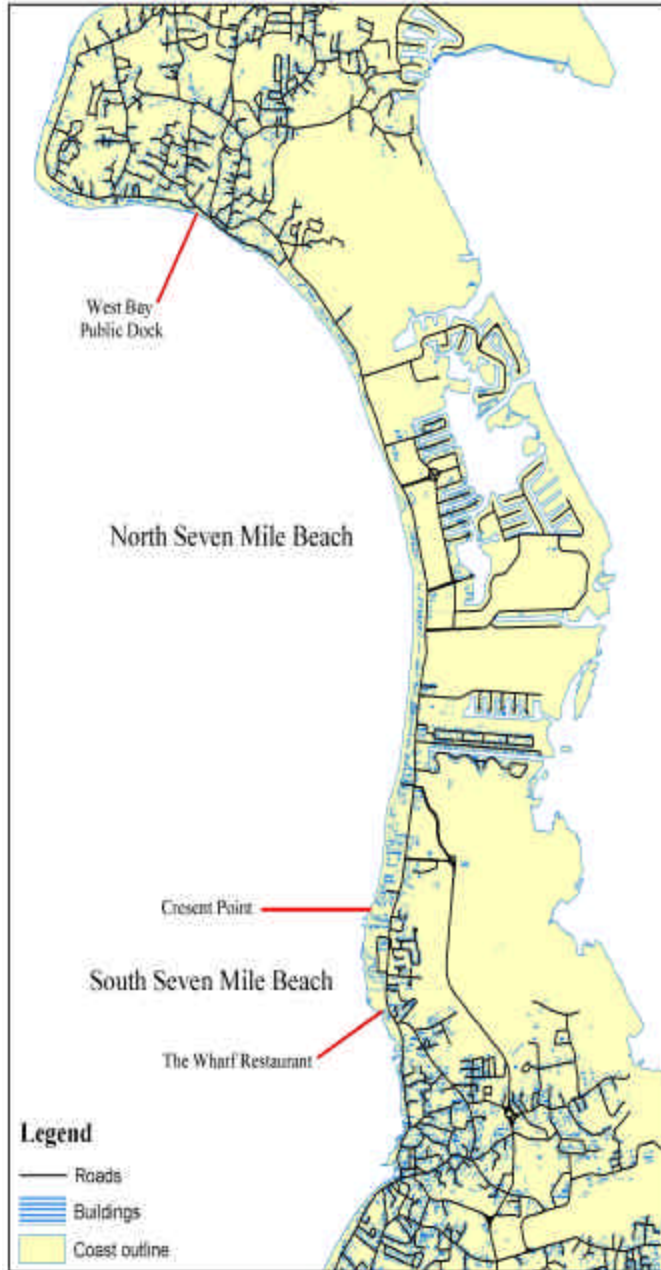
Figure 1: Map of the West Bay Peninsula showing the two separate sand transport systems identified in the Interim Report.

In addition the Committee was advised that within the defined geographical boundaries of Seven Mile Beach there exists two distinct sand transport systems that can be considered as separate systems (Seymour, 2001; Roberts 1977). These systems can be defined as (i) North of Crescent Point (Block 13B Parcel 7 to Block 5B Parcel 179) and (ii) South of Crescent Point (Block 13B Parcel 7 to Block 13E Parcel 165) and which, by nature of the different sand transport systems, will most likely require different solutions to erosion problems. While many of the recommendations outlined in this report are applicable to the whole of Seven Mile Beach and beaches and coastlines in general a few recommendations, mainly dealing with nourishment issues, are only applicable to the sand transport system North of Crescent Point. Recommendations only applicable to the section North of Crescent Point will be highlighted. The Committee anticipates further recommendations for the areas South of Crescent Point that will be reviewed and included in the full report.

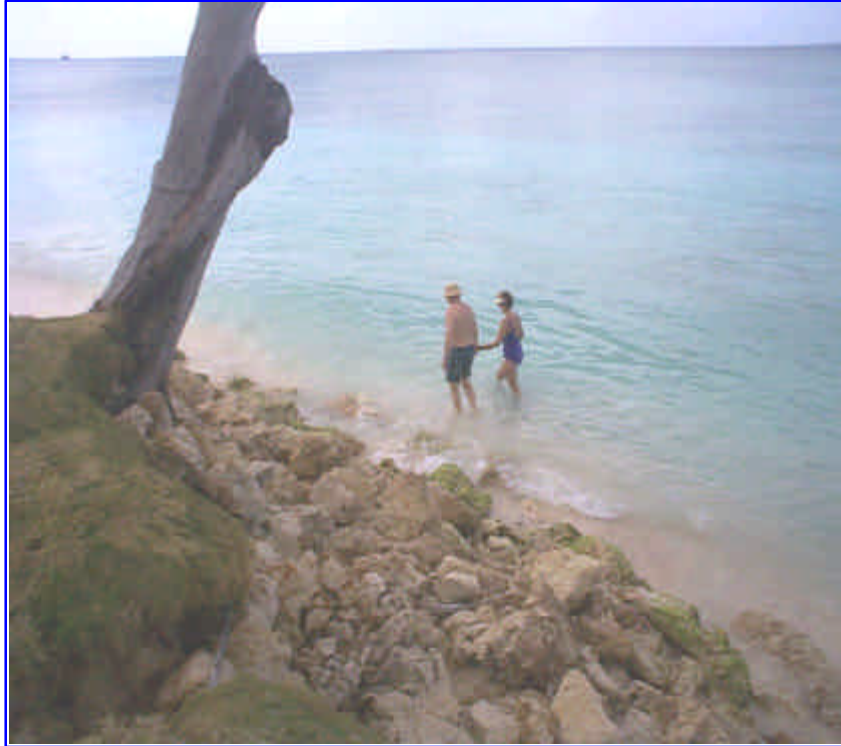
Figure 2: Alongshore access blocked by poorly sited structures.

The opinion of both beach consultants who recently visited Grand Cayman (Dr. Richard Seymour and Mr. Ralph Clark, PE) is that the Seven Mile Beach system North of Crescent Point, although currently experiencing sporadic heavy erosion events, is a relatively healthy, stable system. Much of the heightened perception of erosion has been caused by periodic blocking of alongshore access in a few areas due to loss of beach and the presence of obstructions (Figure 2).

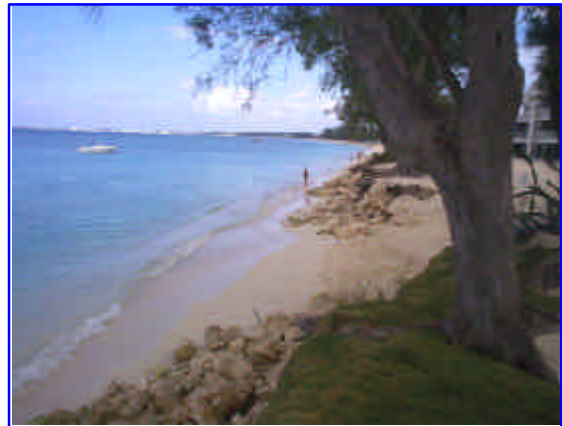
Figure 4 & 5: Examples of rubble structures currently obstructing alongshore beach access.

- (a.) There are perhaps three or four existing rock or rubble structures on Seven Mile Beach which, for short distances, make alongshore access on the beach difficult or dangerous and which prevent the existence of any width of sandy beach because they are placed too close to the sea. In most instances this was done in order to protect Casuarina trees. Examples are the rock revetments at Block 12E Parcels 17 and 91.
- (b.) These structures should be removed immediately and the beach allowed to reestablish an equilibrium profile. It is likely that the Casuarinas will also need to be removed. If the owners of these properties determine a need for a new seawall then the

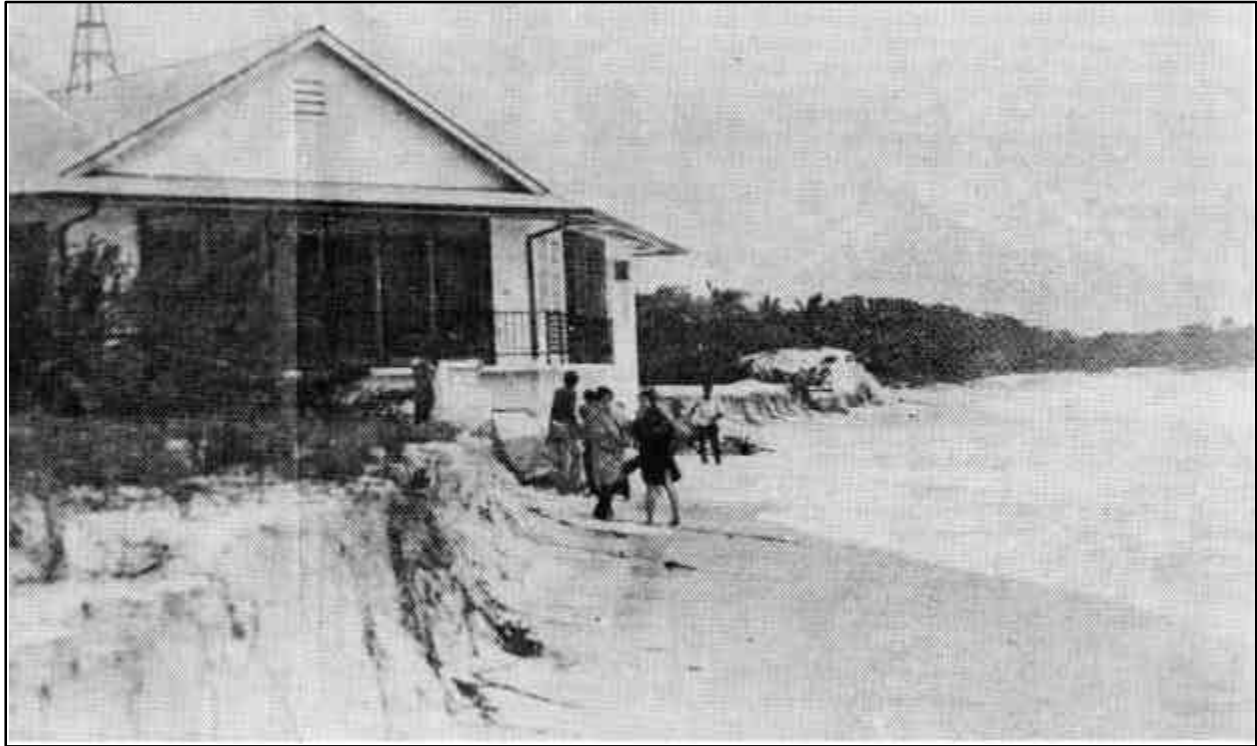
Figure 10: Evidence of erosion on the Southern section of Seven Mile Beach in 1972. Photos: Caymanian Compass.

Photographs of the southern end of Seven Mile Beach (Schoenheit Residence shown) from 1972 depict natural storm-induced erosion corresponding to the vegetation line. Interestingly this erosion still continues to occur to approximately this extent on a regular basis demonstrating that beach erosion is not a new phenomenon and is predictable based on the vegetation line. Note the vegetation line shown in these images is more or less consistent with the interpreted vegetation line shown in the 1999 images.

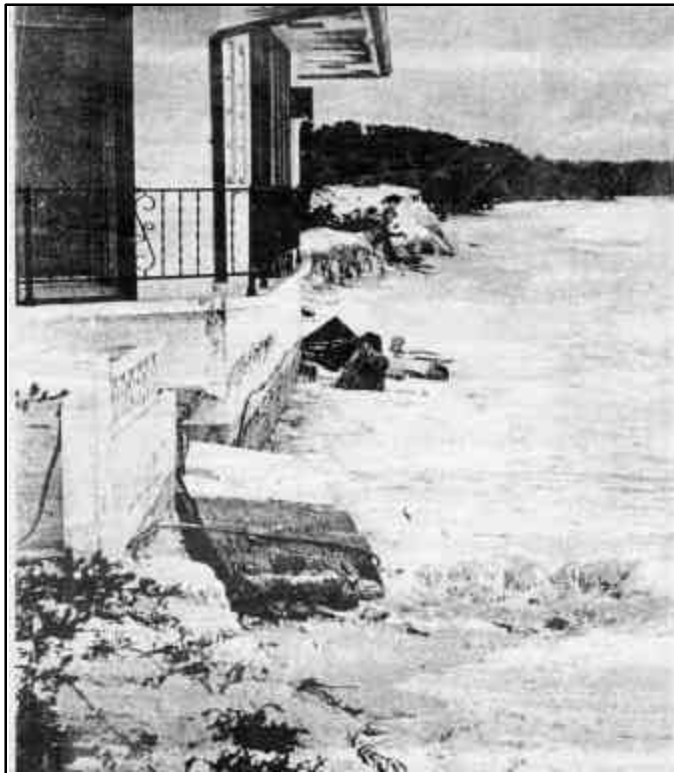
Figure 11: Evidence of erosion on the Southern section of Seven Mile Beach in 1972. Photos: Caymanian Compass.

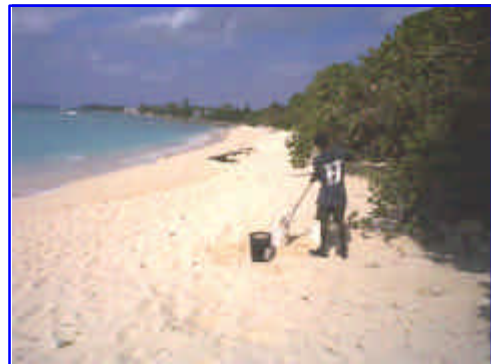
Figure 12: A local individual collecting sand for domestic purposes.

In addition the Development and Planning Law (1999 Revision) Section 31 entitles the general

public to one cubic yard of sand (and other coastal material) from all Cayman beaches for domestic use (Figure 12). **The Committee recommends that this outdated law be amended to prevent the practice of sand removal from all beaches.**

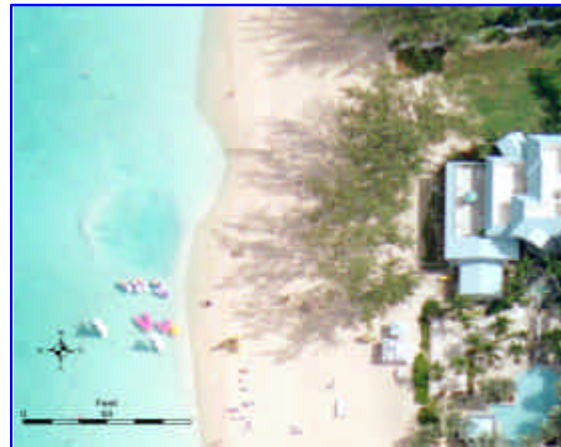
Figure 15: Evidence of local beach erosion hotspots from repeated boat landings.

The Committee has become aware that where boats come up on the beach for the purpose of loading or off-loading passengers localised beach erosion occurs due to the scouring effect caused by propellers (Figure 14 & 15). The Department of Environment has been recently approached by one watersports operation for permission to “correct” the problem caused by the buildup of sand seaward

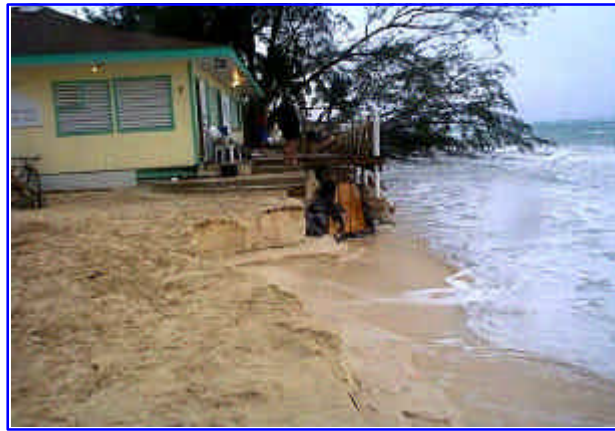
Figure 1

even though it has been significantly eroded. The picture shows clearly that visitors to the beach are utilising this stretch of beach and are most likely unaware that the beach is significantly eroded at this stage. If the structure had remained in place a healthy beach profile would not have formed and beach access would be blocked by the building in the water (Figure 1), significantly increasing the

The Royal Palms, Seven Mile Beach, provides an excellent example of a persistent erosion problem that was corrected by removal of a structure that had been placed too close to the active beach. The series of photographs below show the same stretch of beach both when the structure was present (Figure 1) but damaged by waves and erosion creating a lateral beach access problem, and at a later stage when the structure was

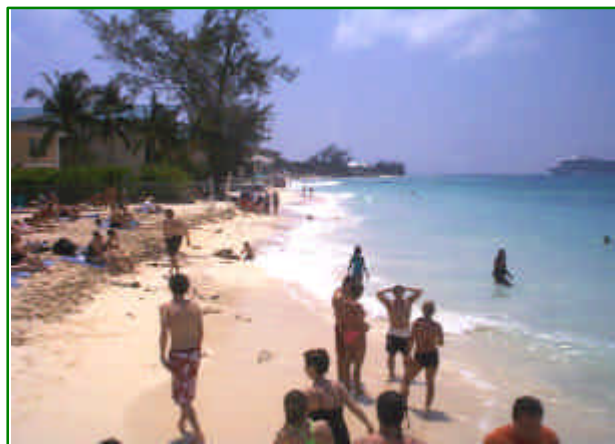
voluntarily removed to allow the beach to fluctuate (Figure 2). Figure 3 shows the Royal Palms Beach following the recent March 2003 heavy erosion event that caused extensive erosion on the Southern end of Seven Mile Beach. Figure 3 clearly illustrates that a healthy beach profile now exists in the area
